Division of
Oil, Gas & Mining

TO: Minerals File
FROM: Thomas Munson, Senior Reclamation Hydrologist *T.M.*
SUBJECT: Site Inspection, Intrepid Wendover Potash LLC, Bonneville
Plant/Reilly, M045/002, Tooele County, Utah

Date of Inspection: July 1, 2004
Time of Inspection: 10:30 a.m.- 3:00 p.m.
Conditions: Partly cloudy and hot
Participants: Wayne Hedberg, Doug Jensen, and Tom Munson, DOGM;
Stan Perks and Bill White, BLM; Rich Schowengerdt and
Brian Bartoszek, Shaw Environmental; Rick York, and
Greg Foy, Intrepid

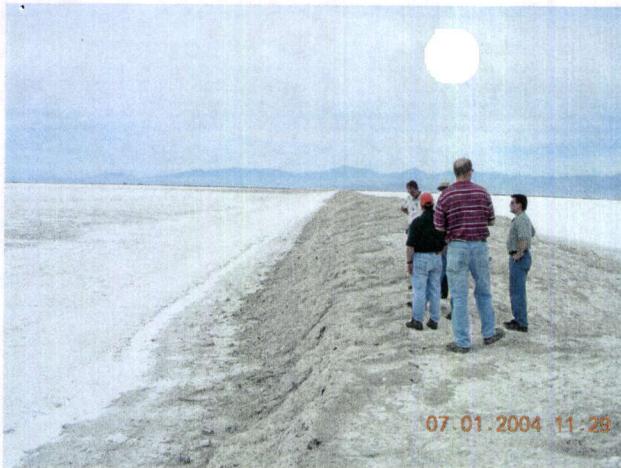
DSCN2077.JPG 2004/07/01 11:29:10

Salturo Loop Dike & Canal
(salted in) view is west

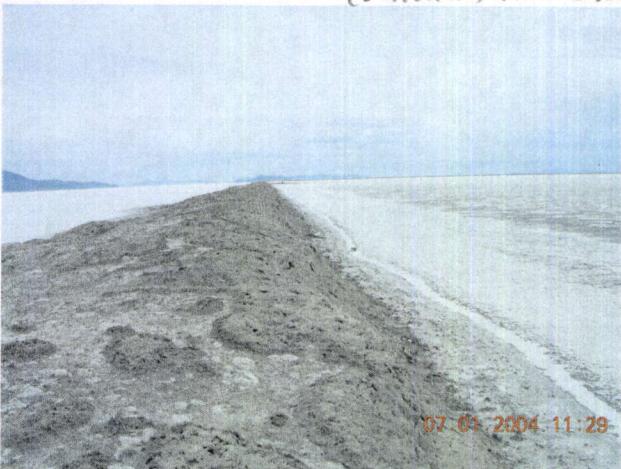
DSCN2079.JPG 2004/07/01 11:29:38

Salturo loop (Dike & salted)
in canal (East view)

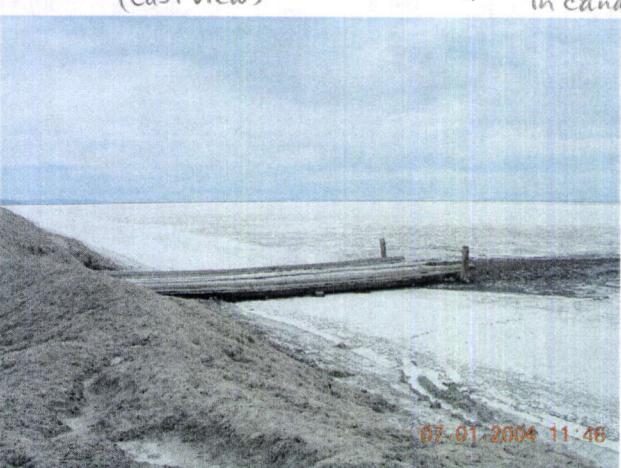
DSCN2081.JPG 2004/07/01 11:46:29

Old bridge crossing - Salturo
(canal salted in) Loop

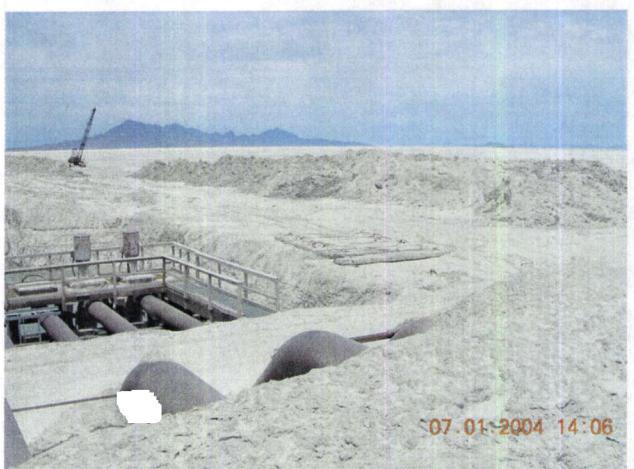
DSCN2100.JPG 2004/07/01 14:06:09

Intake pumps
to 1^o Pond VI.

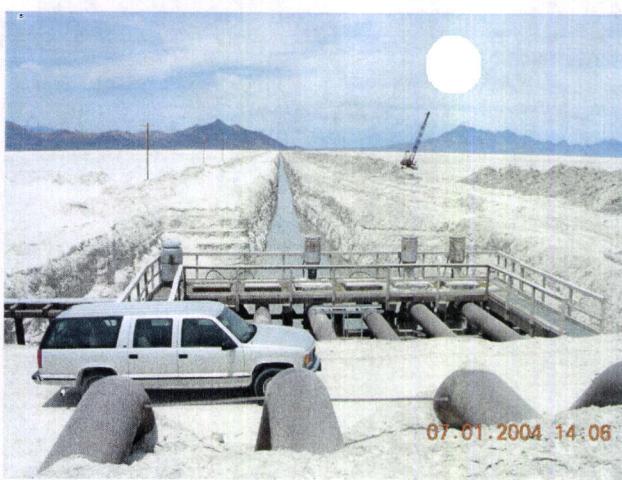
DSCN2101.JPG 2004/07/01 14:06:19

2
Main collection canal & intake pumps to Primary evap pond # VI

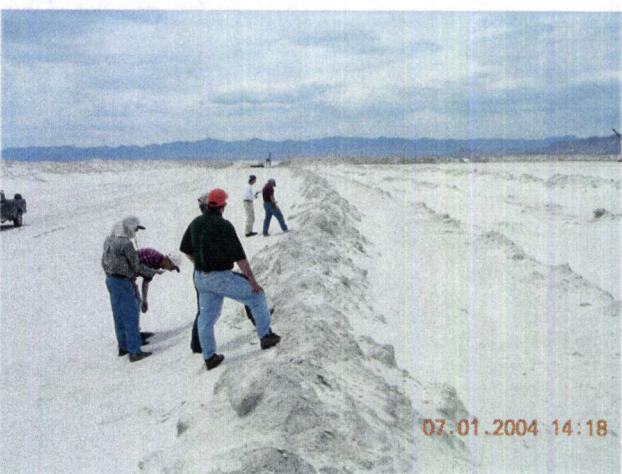
DSCN2105.JPG 2004/07/01 14:18:05

4
Are a adjacent (west) of Pond VI showing natural filling of wind blown gypsum/salt sands (View South)

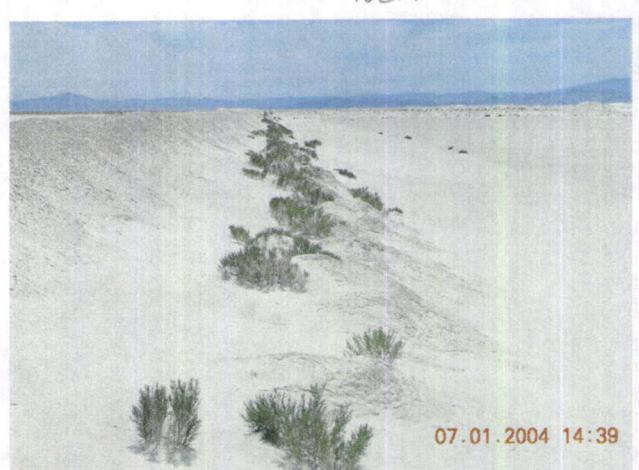
DSCN2124.JPG 2004/07/01 14:39:35

Voluntary Vegetation on drifted sands against dunes

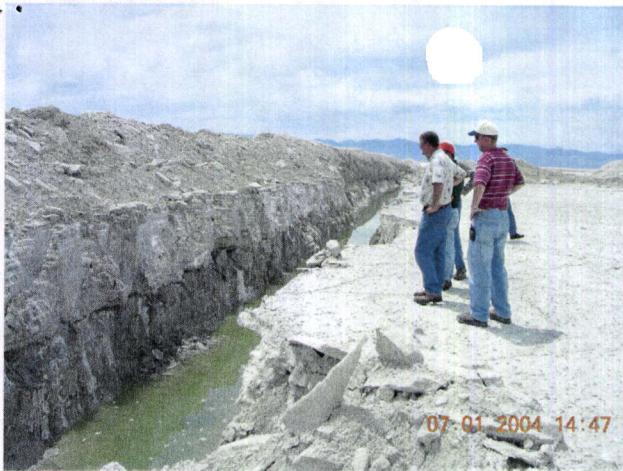
DSCN2125.JPG 2004/07/01 14:47:07

collection
ditch
cut
thru
pond 5

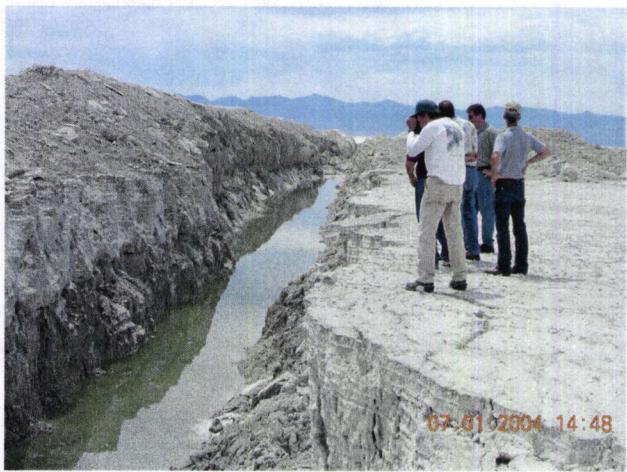
DSCN2129.JPG 2004/07/01 14:48:43

Pond IV
internal
collection
ditch

brine
seepage
into
ditch
